BUREAU OF SHIPS GROUP

TECHNICAL INSPECTION REPORT

U.S.S. SKATE (SS305)

TEST ABLE

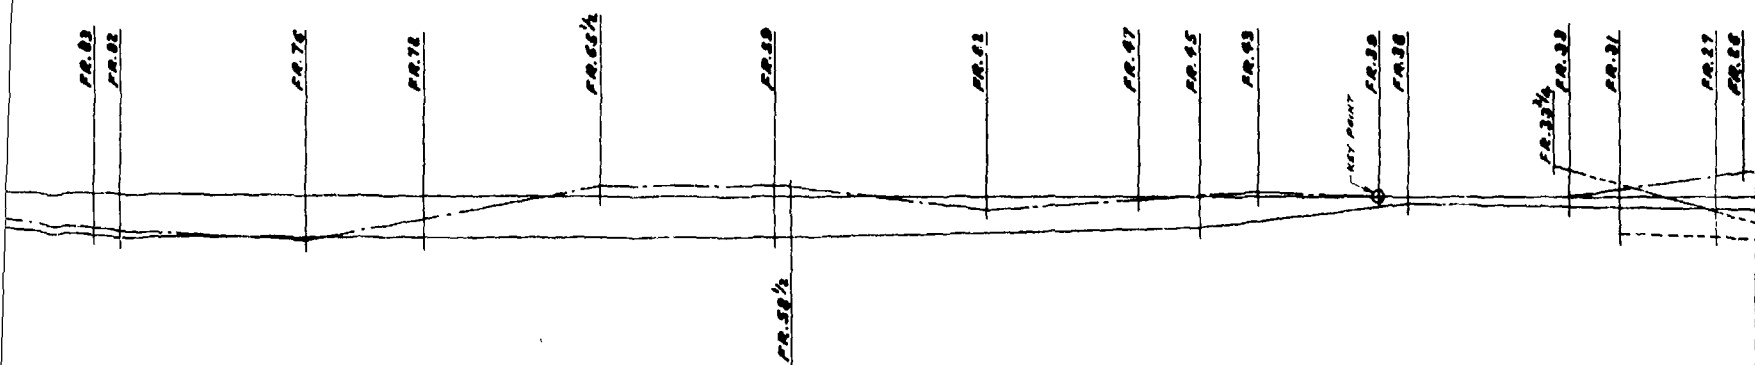
respectively, as a result of failures at the connection to their foundations. A survey of the keel and builders centerline punches in the opt of the frames was made in drydock at the Naval Shipyard Mare Island. The results are plotted in Plate I, page 96. The off-sets of the structural hull between the forward perpendicular and frame 103 are not greater than the variations to be expected in building or in making such a survey.
